PRENDOS Limited

RISK EVALUATION

BUILDING WEATHERTIGHTNESS

Pilot Study of Weathertightness Failures

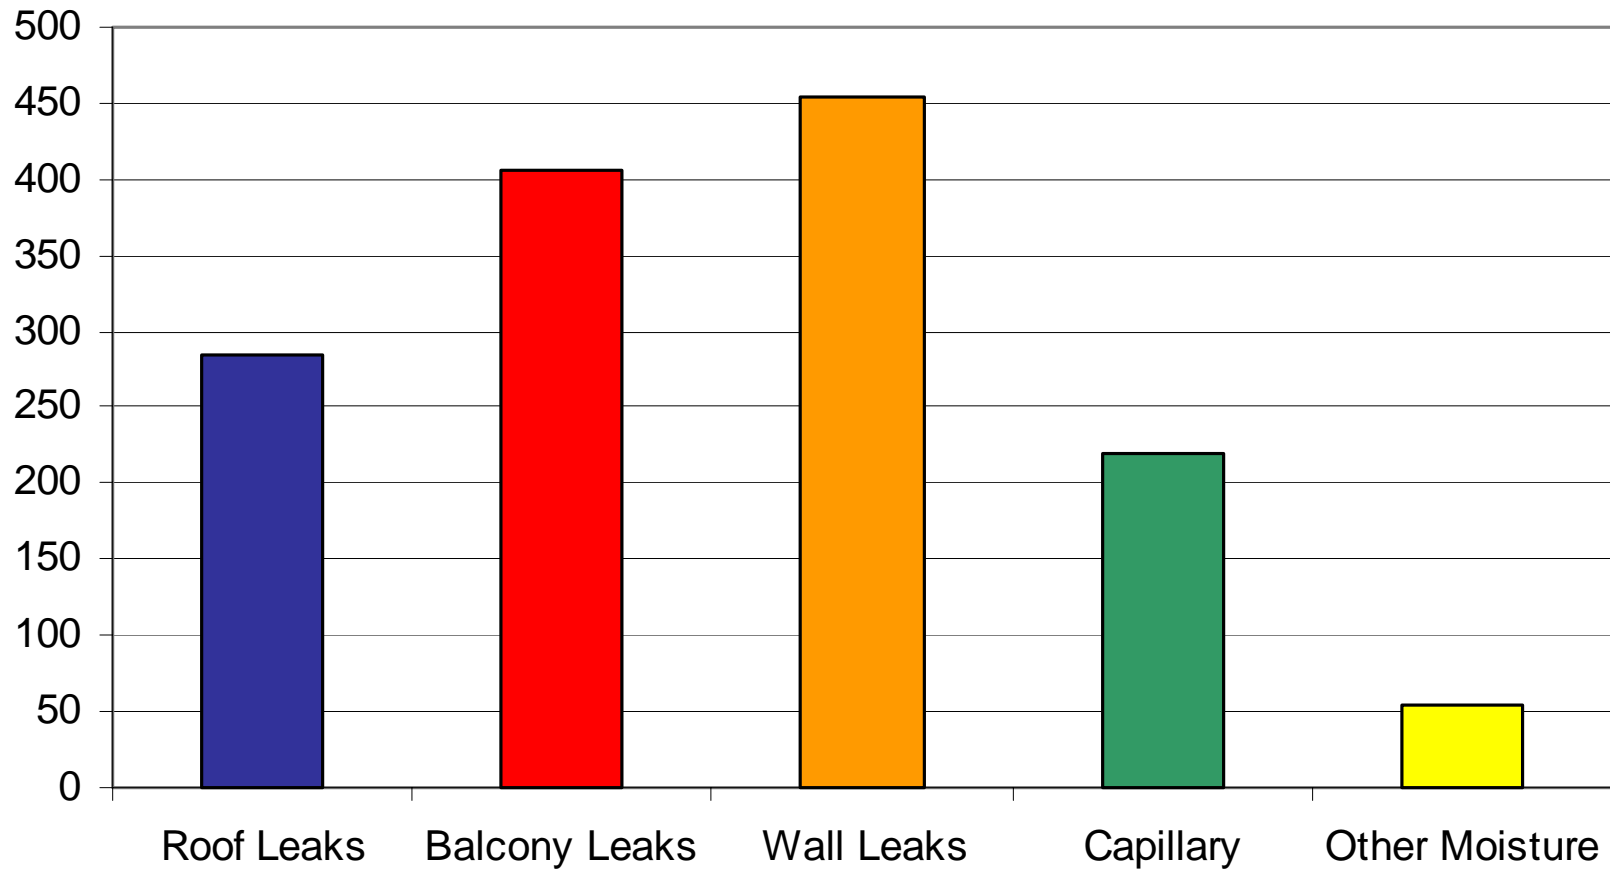
Water Sources and Frequency

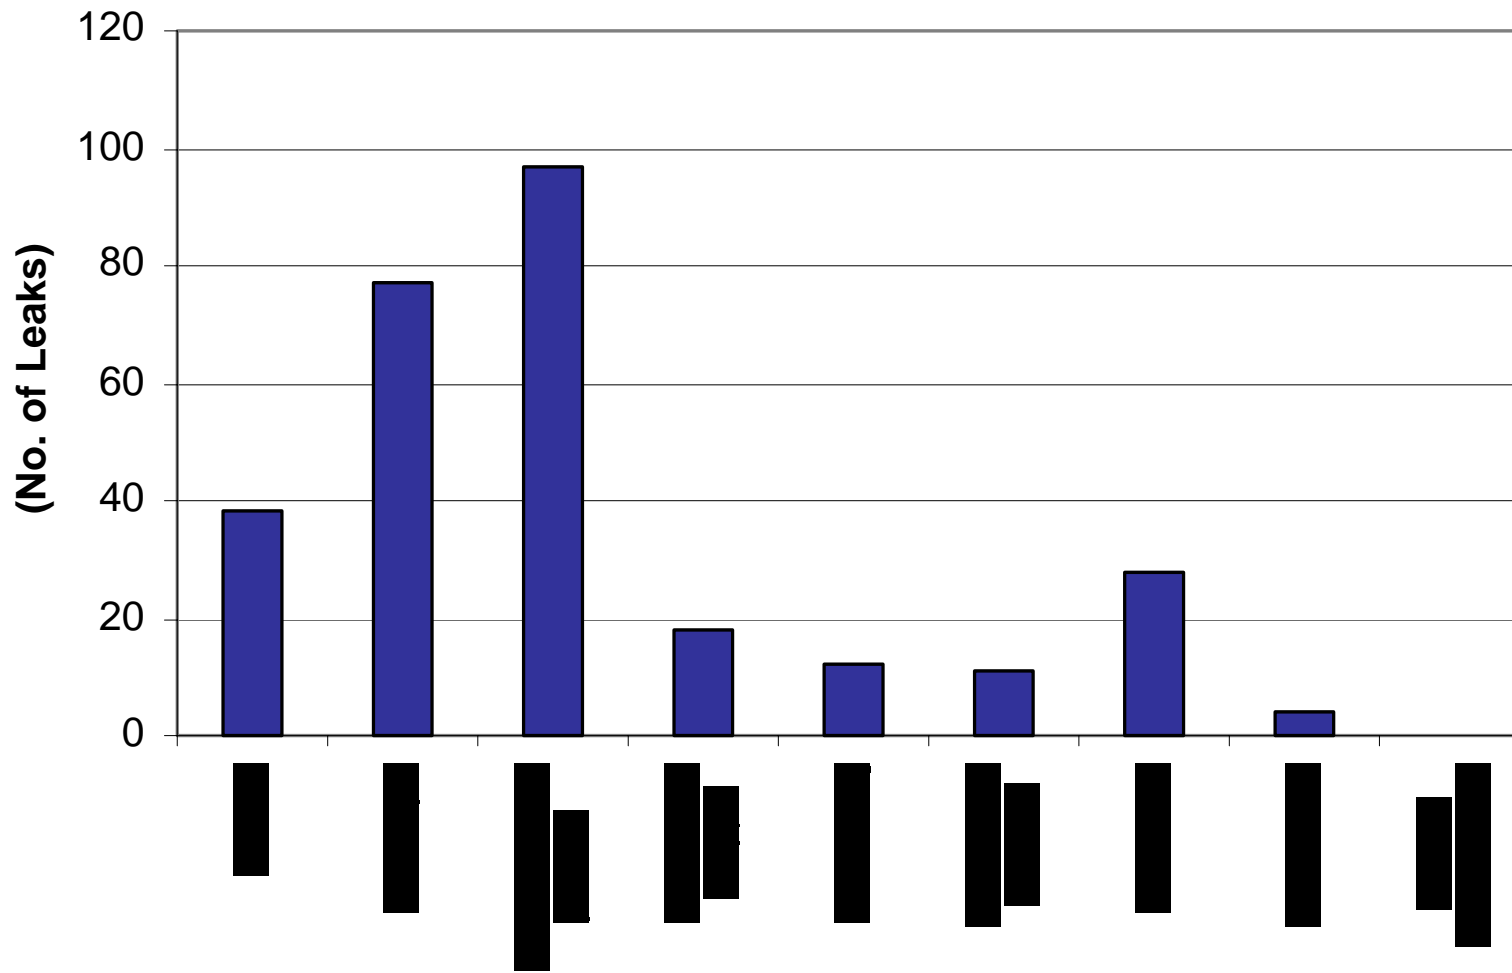
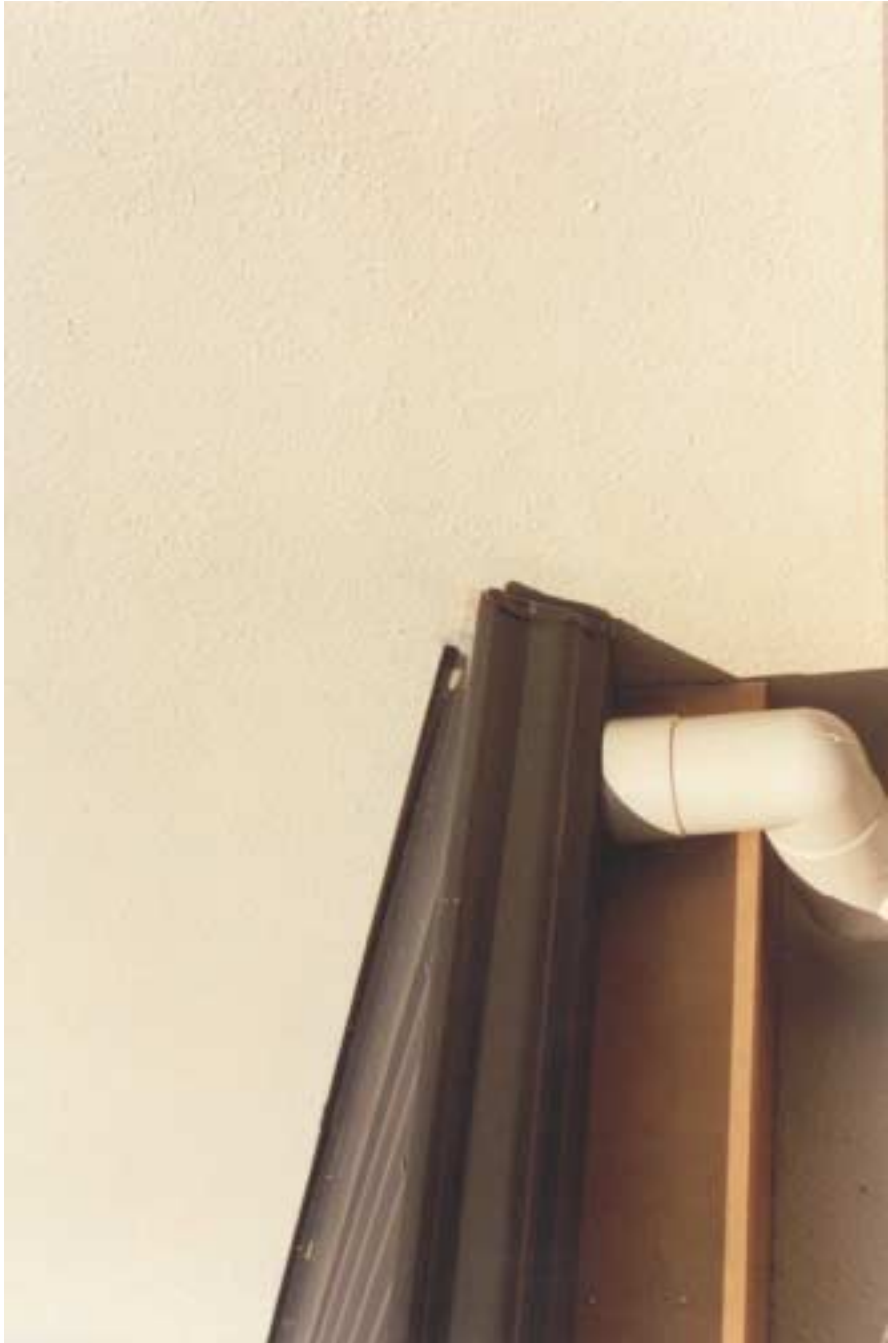
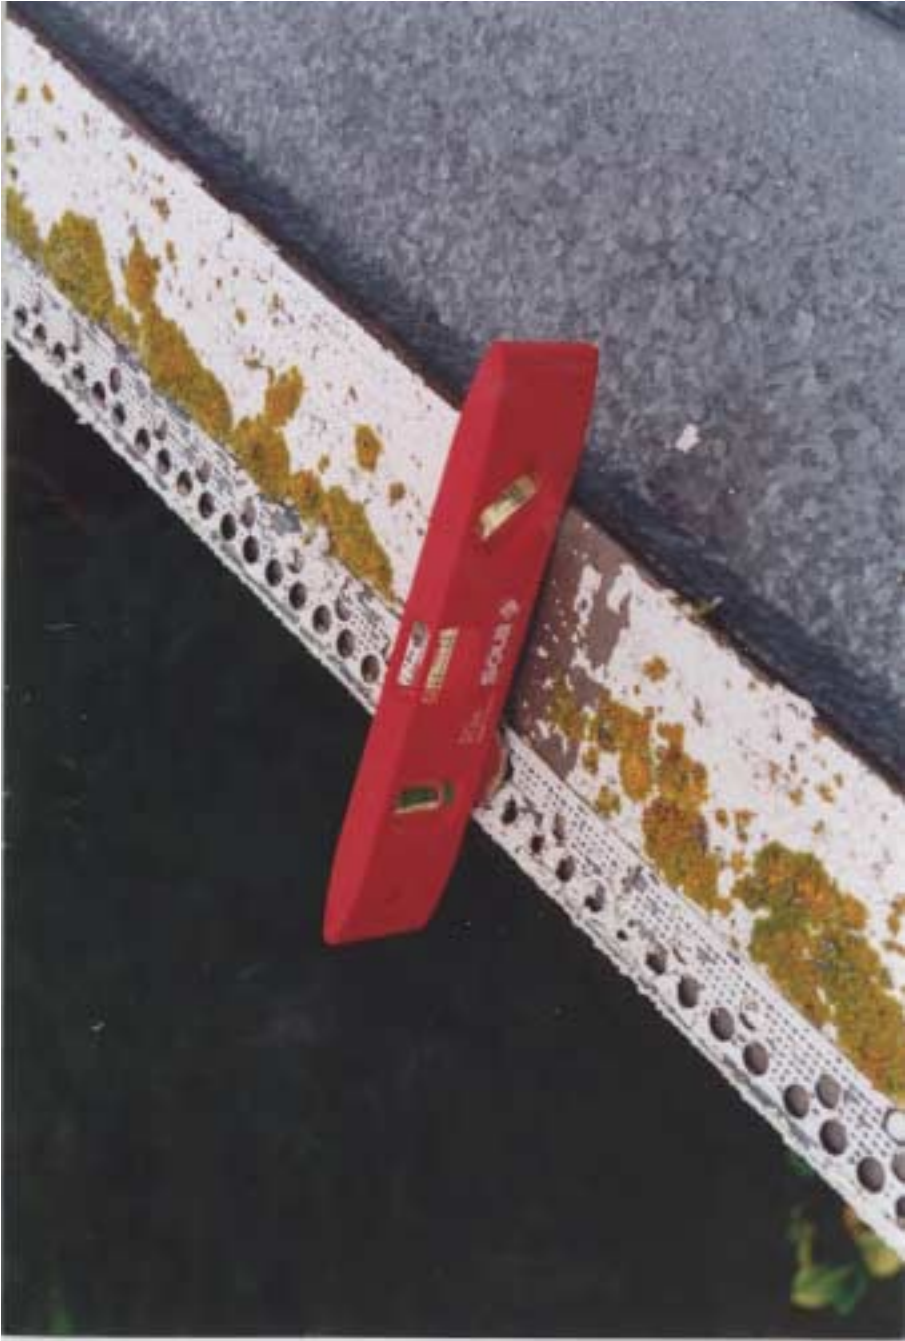
Roof Leaks

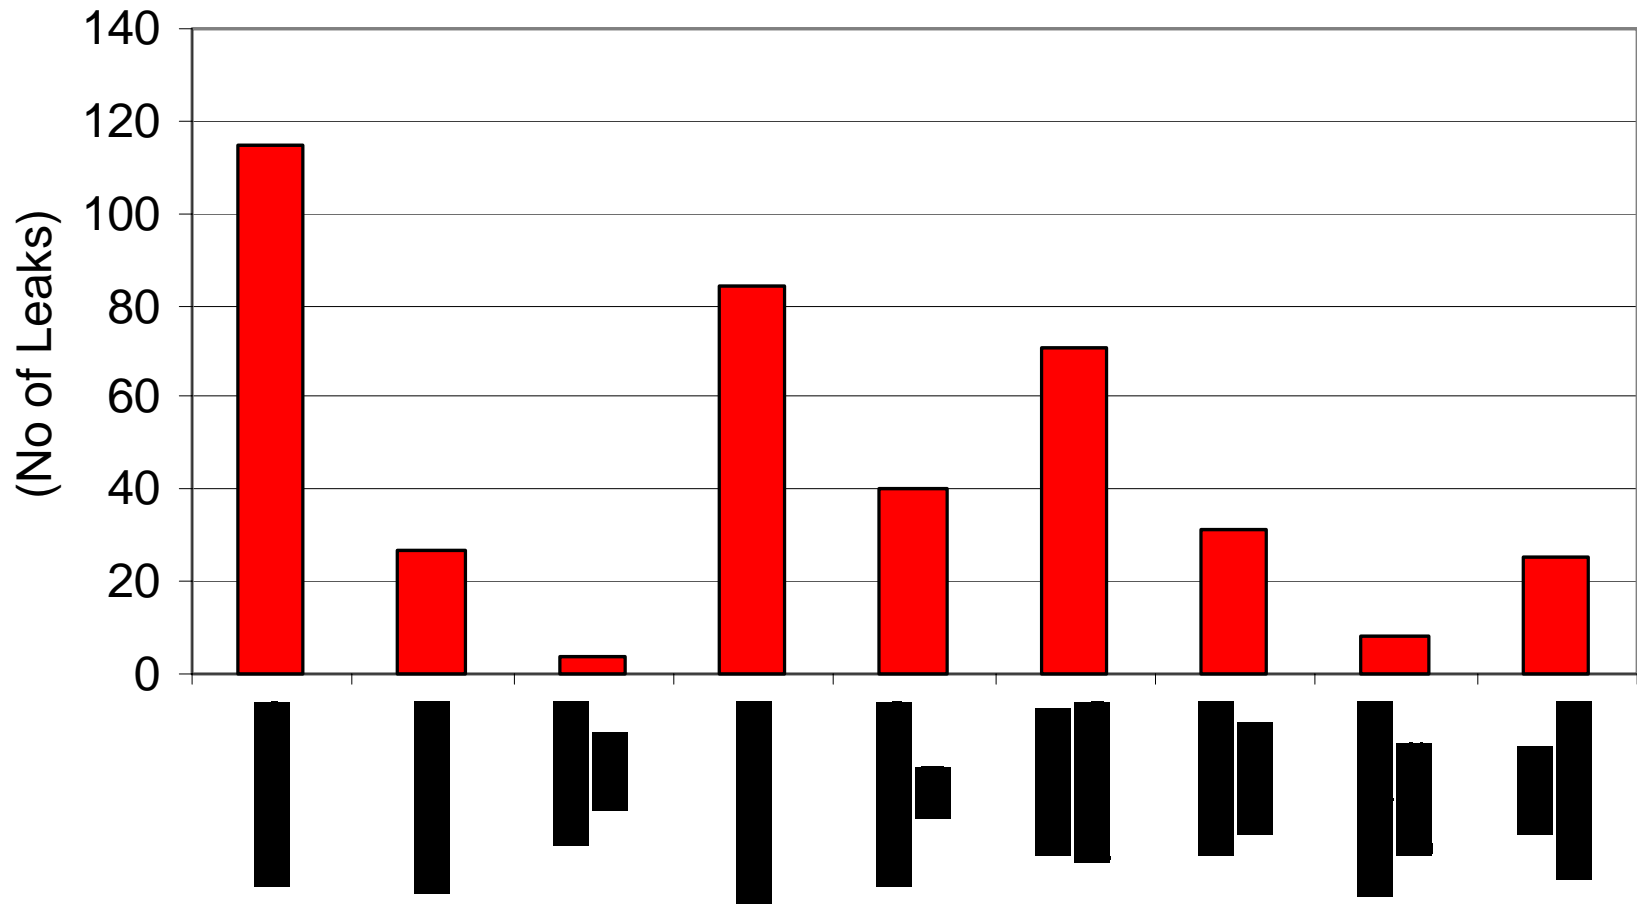
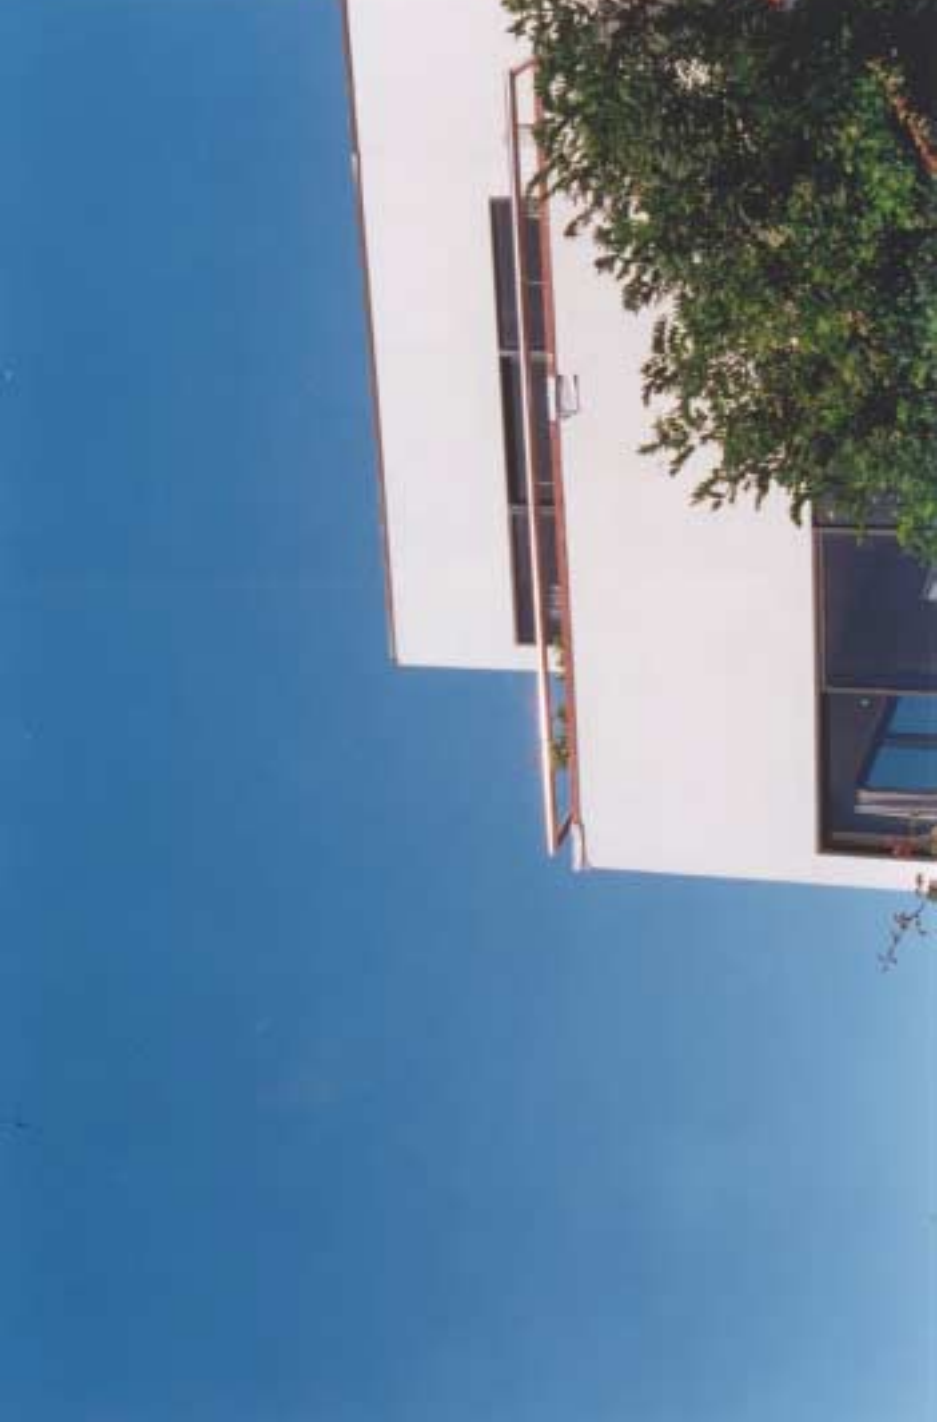
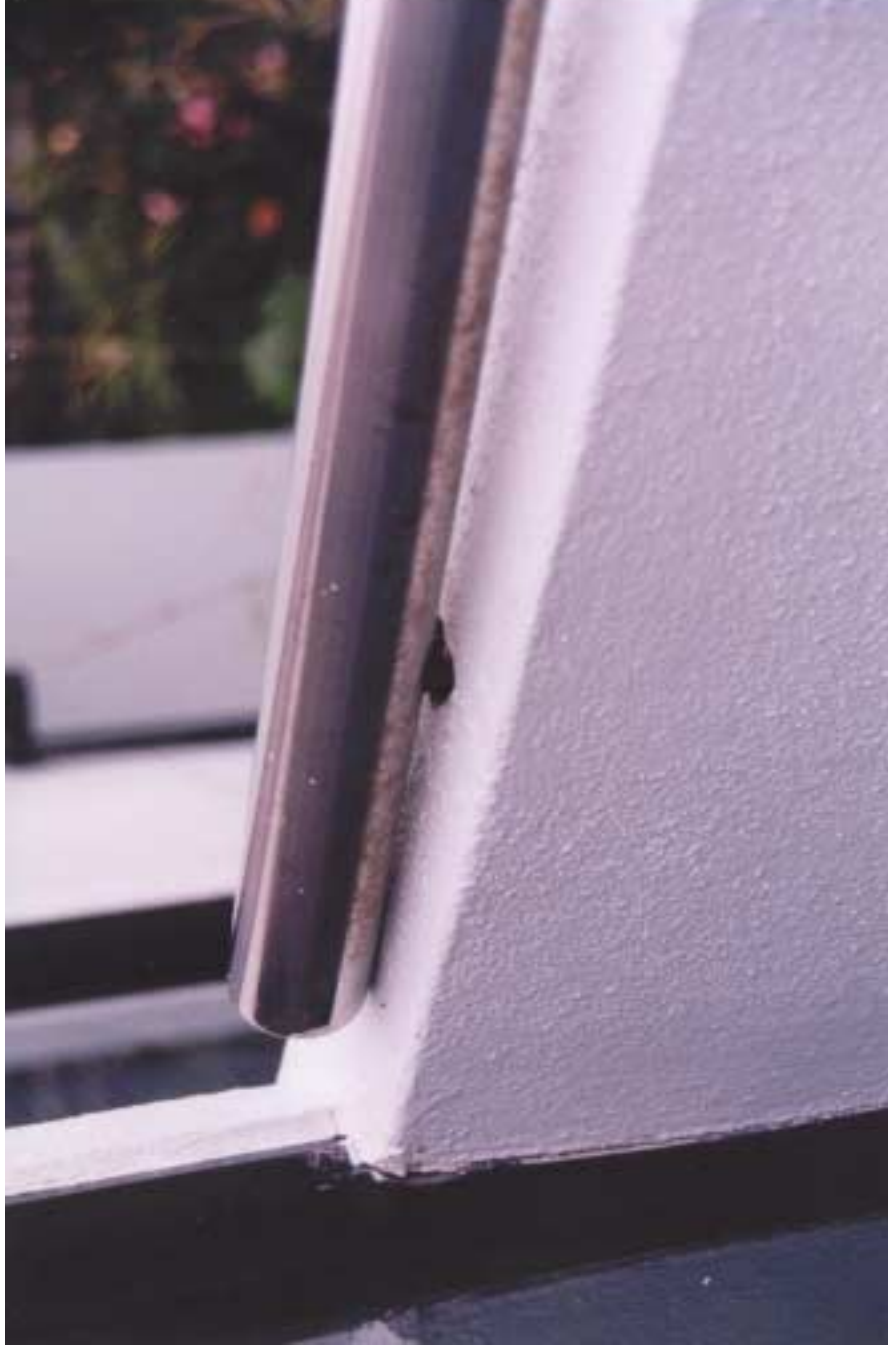
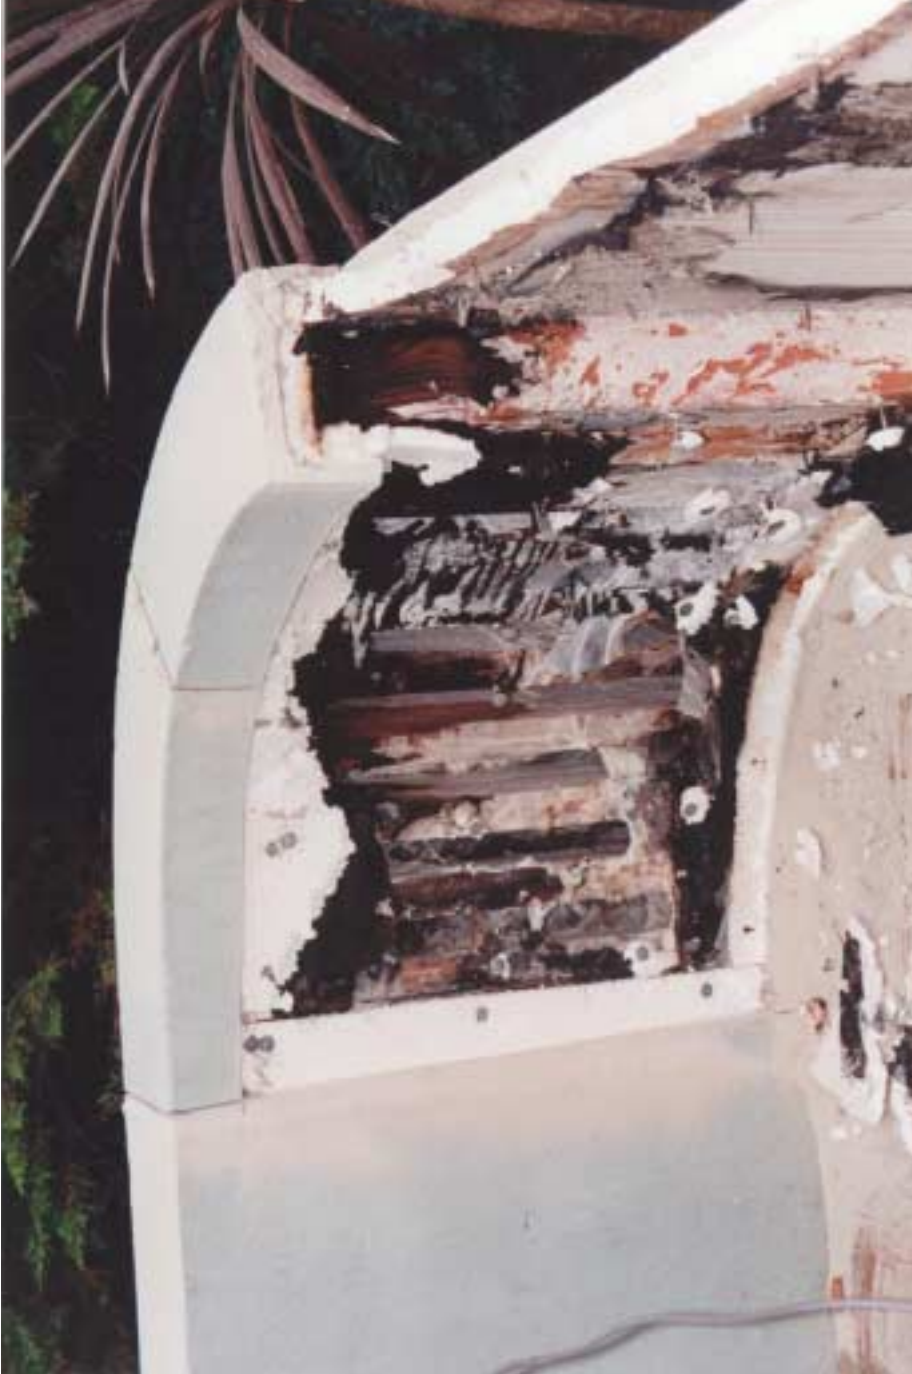
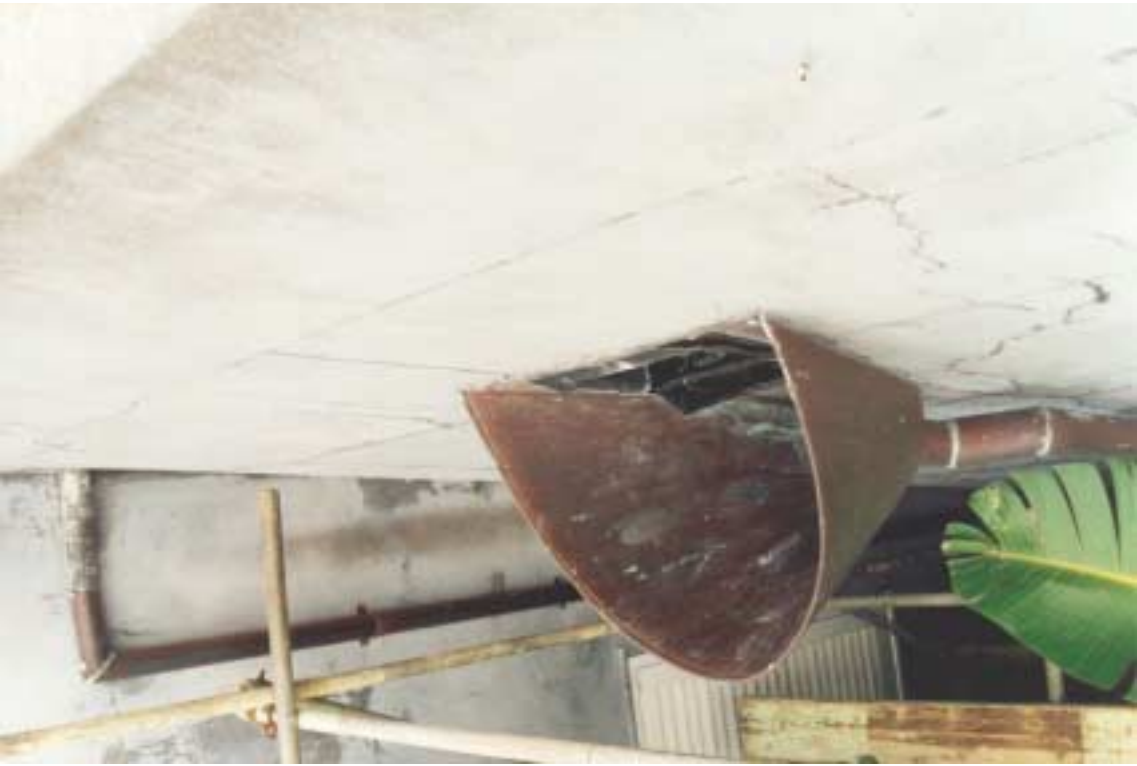
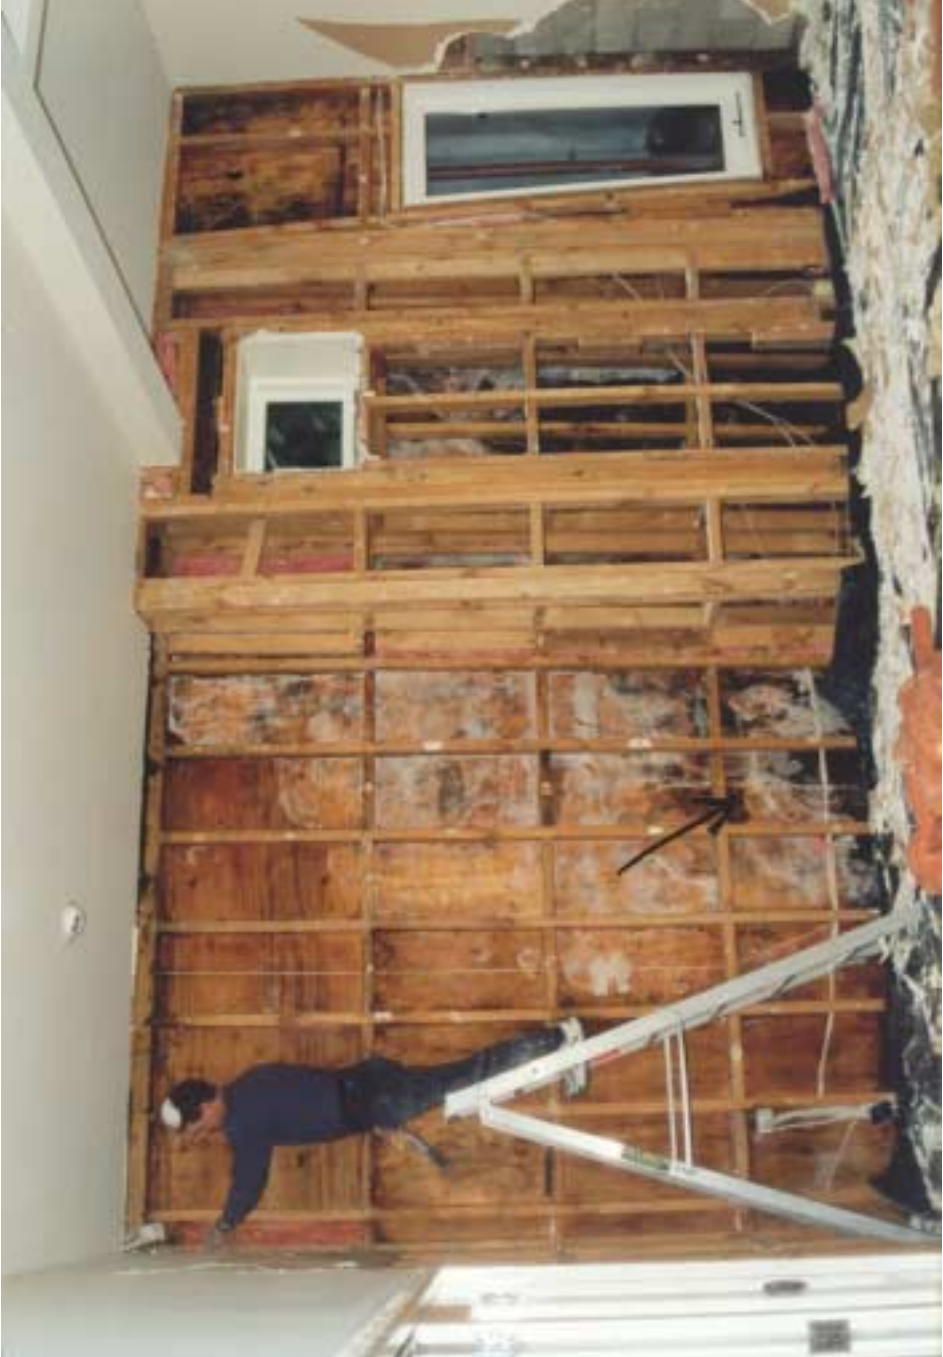
39 of 50 sites had balconies

39 of 50 sites had balconies that leaked

Balcony Leaks

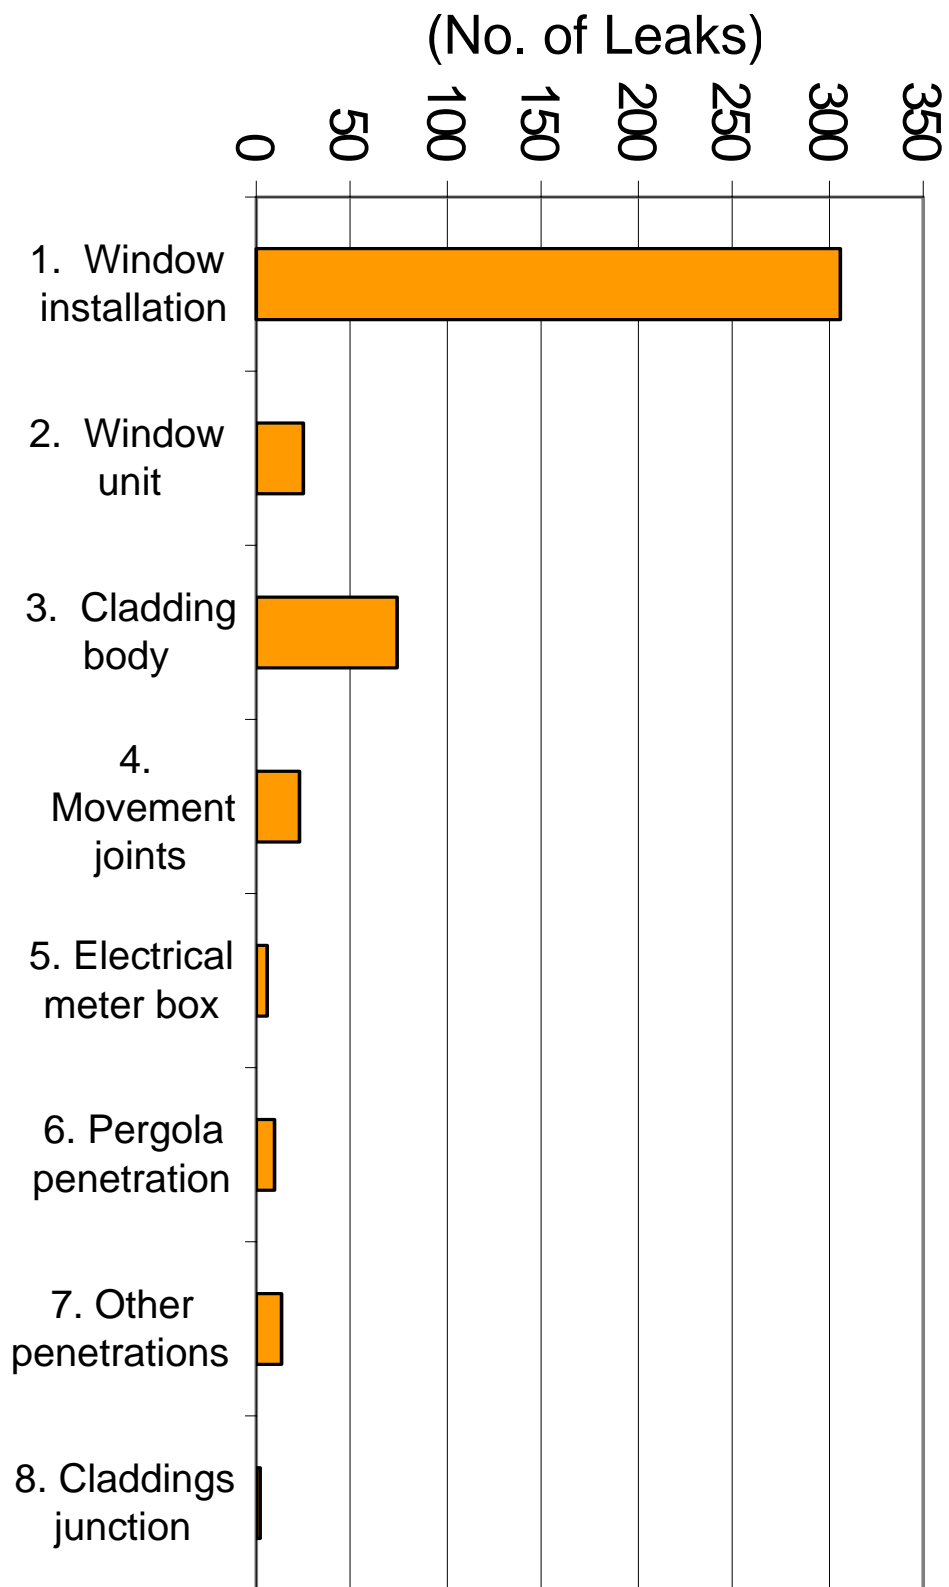
Wall Leaks

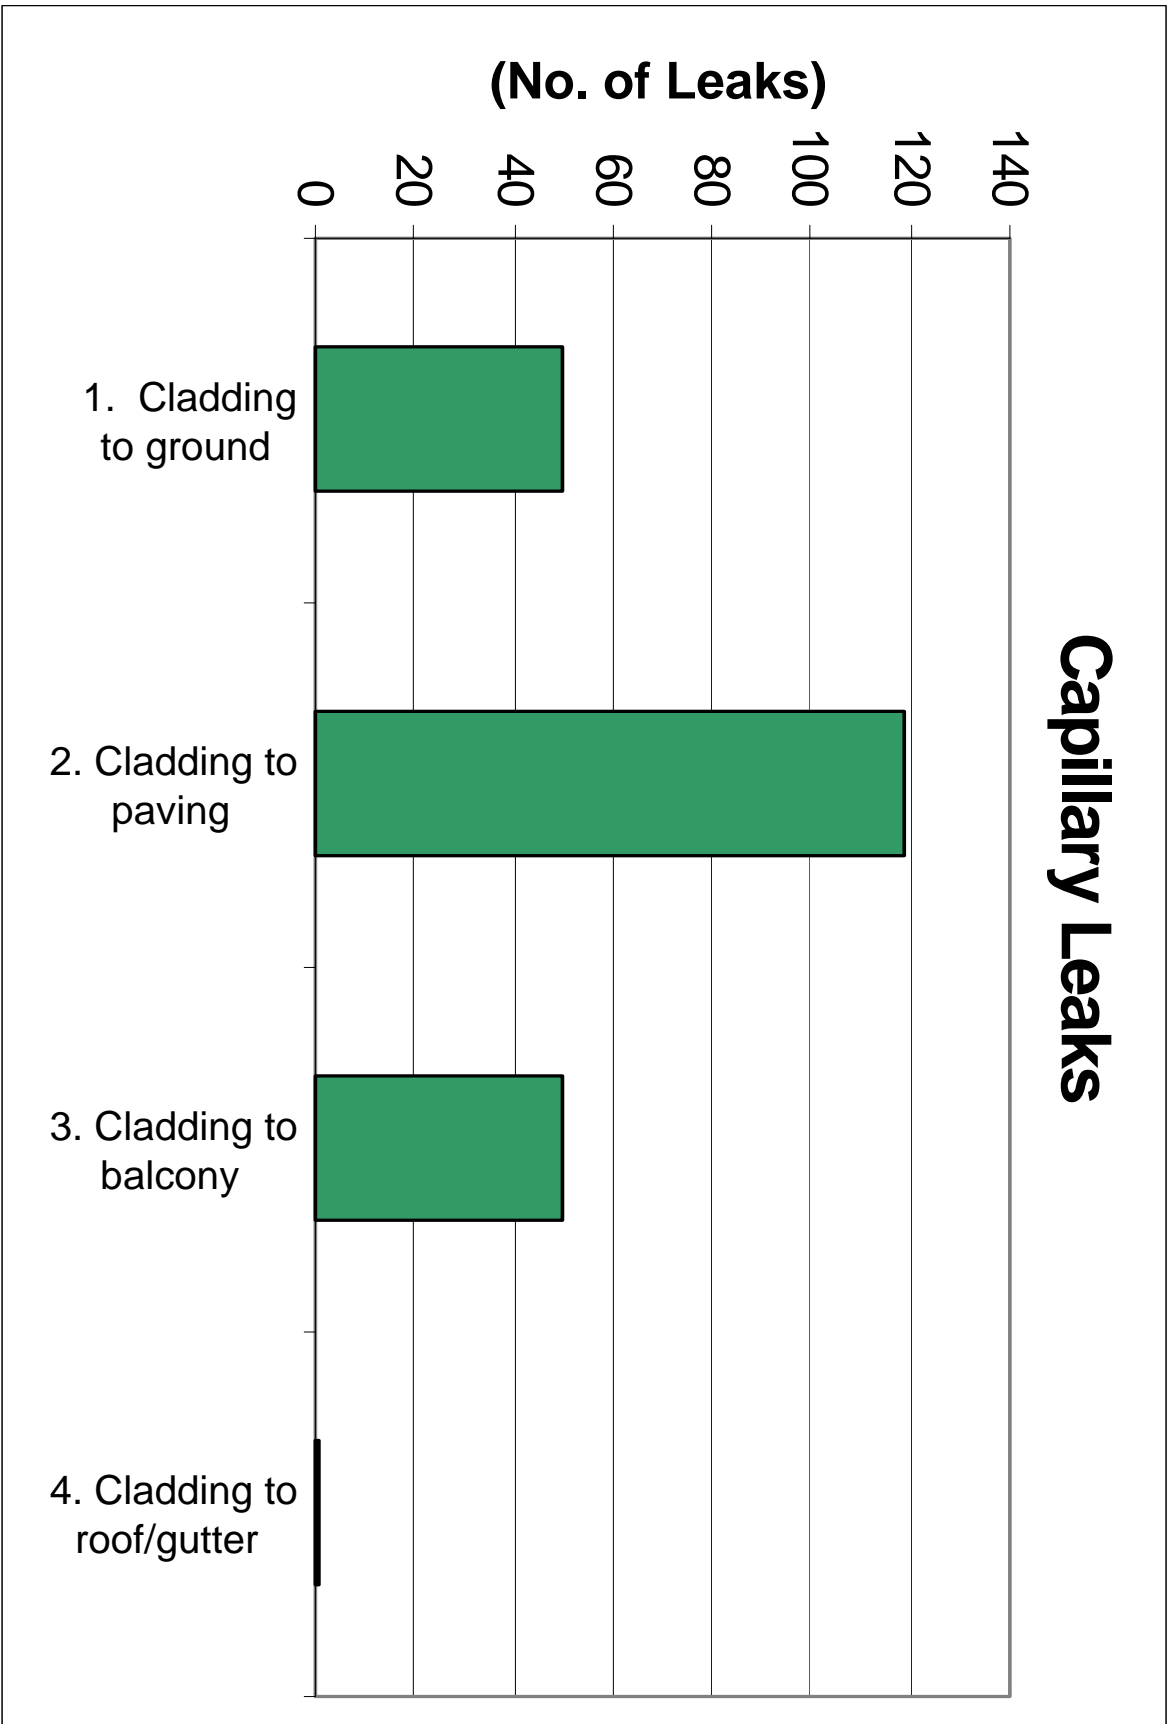
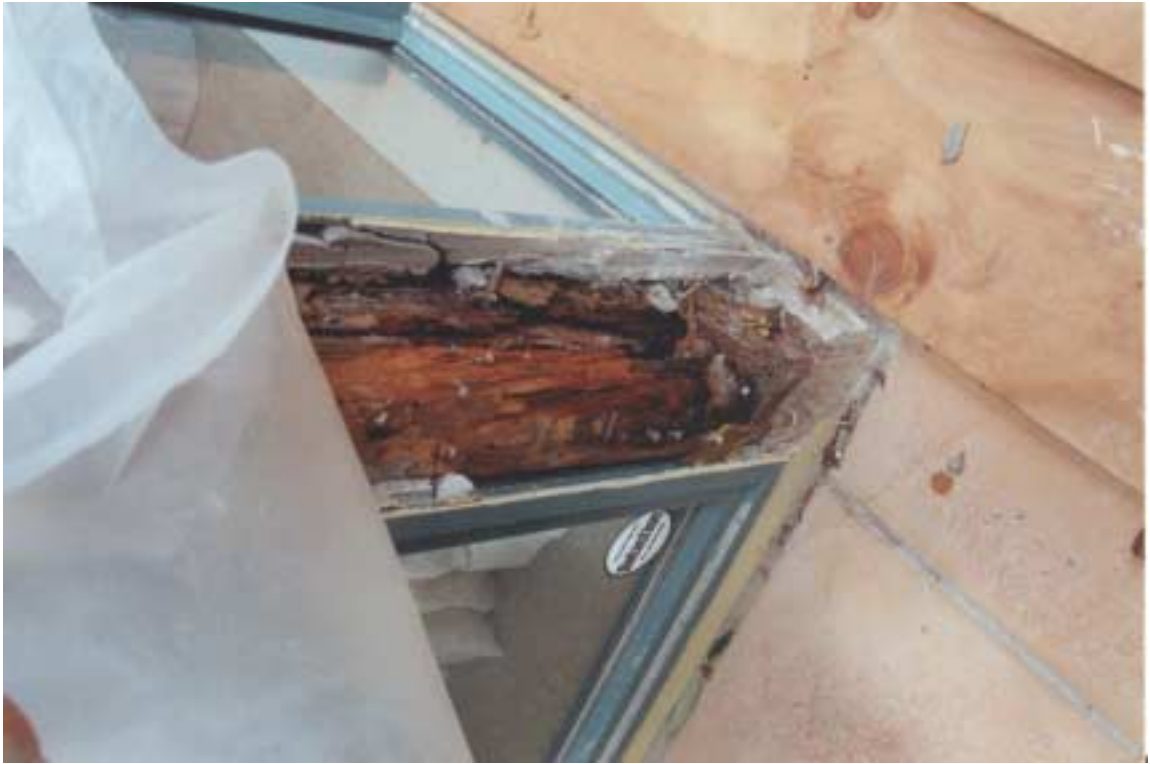
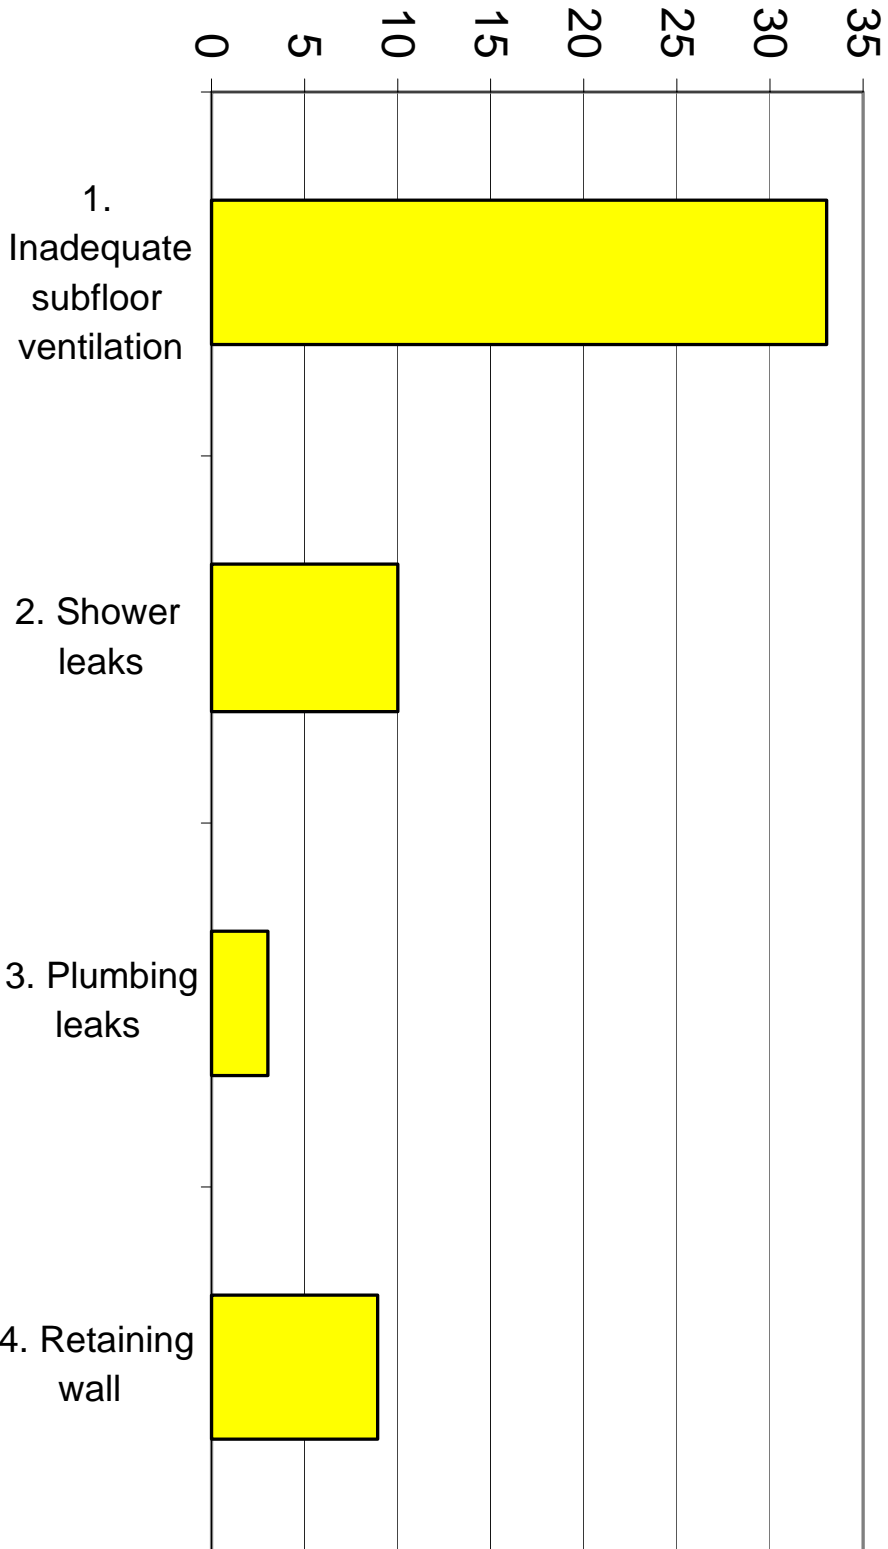
Capillary Leaks

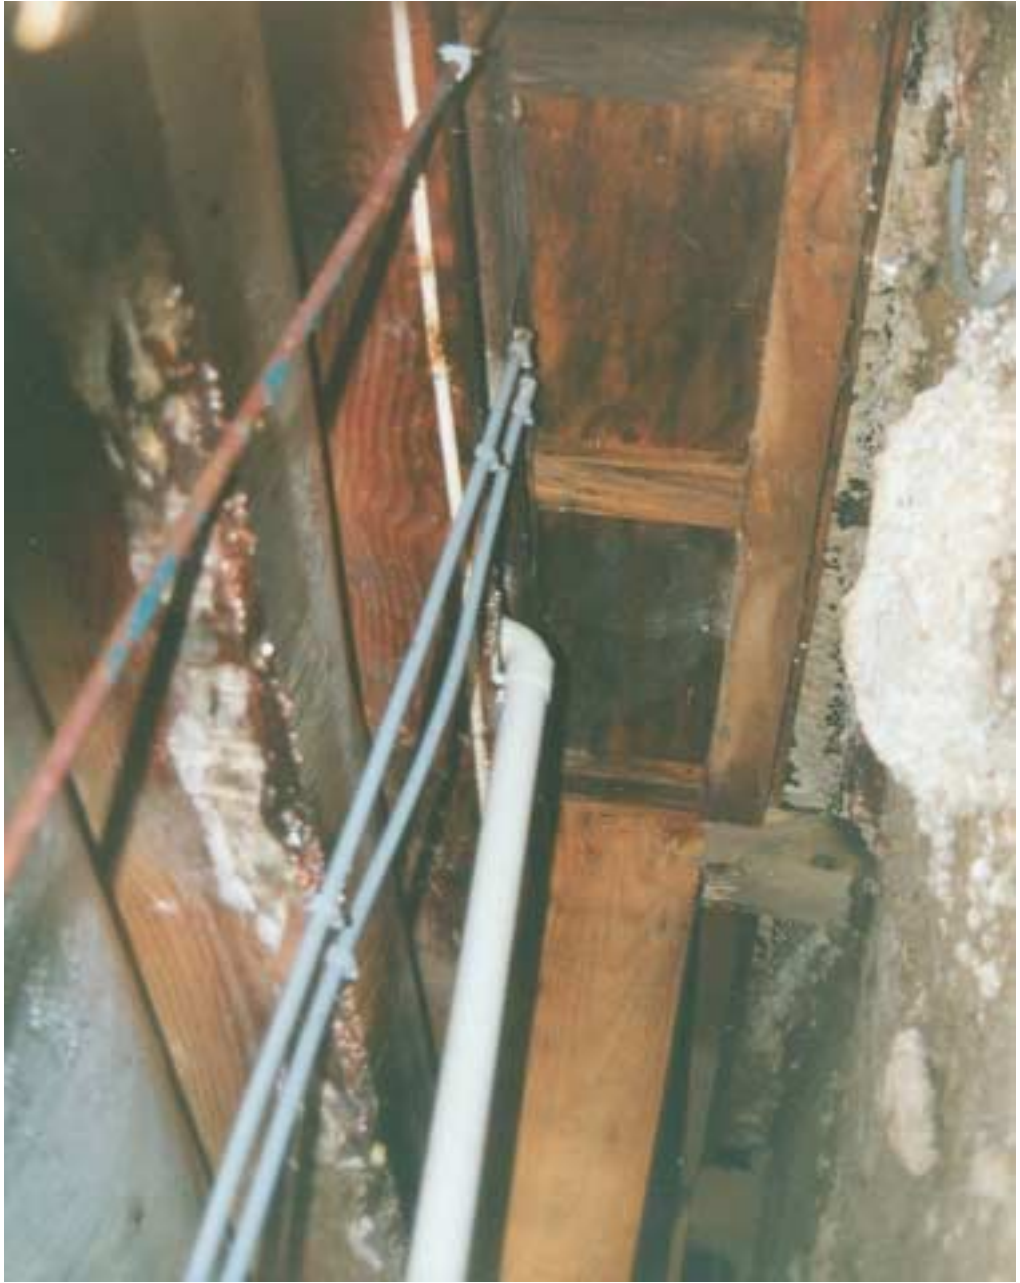
Other Leaks

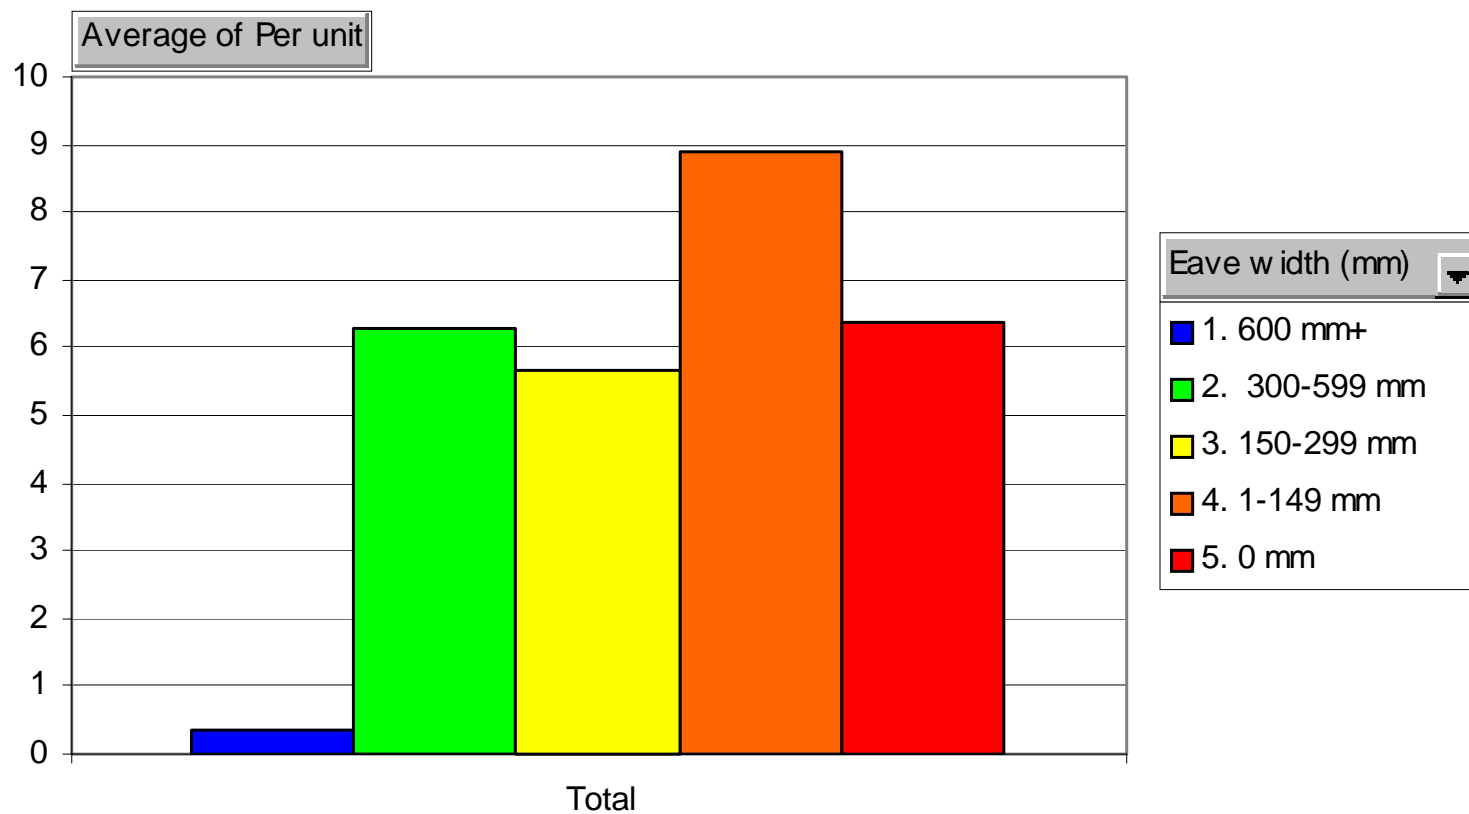
Roof Eave Width vs Wall Leaks Per Unit

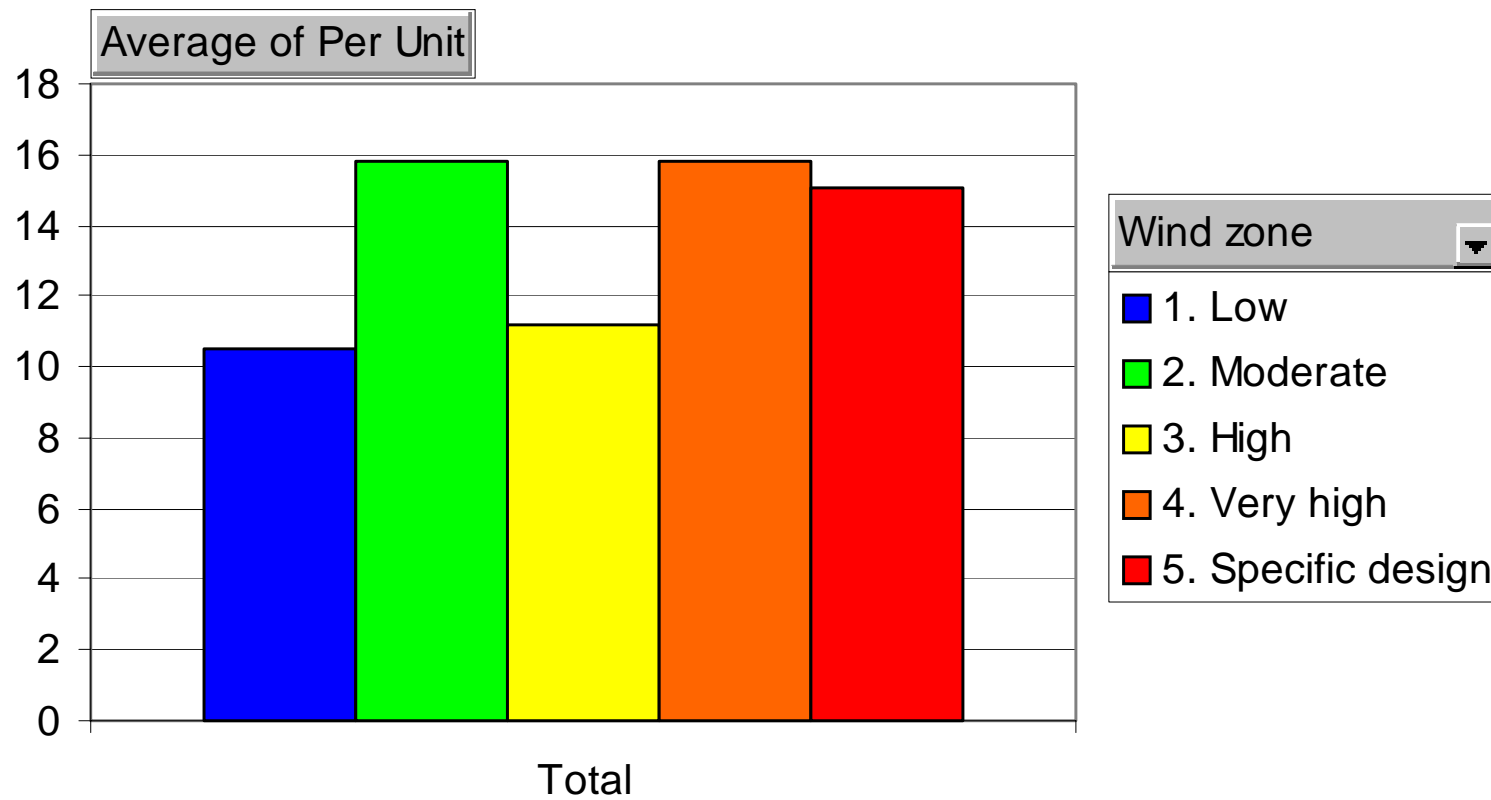
Wind Zone vs Wall, Roof and Balcony Leaks Per Unit
