PRENDOS Limited

RISK EVALUATION

BUILDING WEATHERTIGHTNESS

Pilot Study of Weathertightness Failures

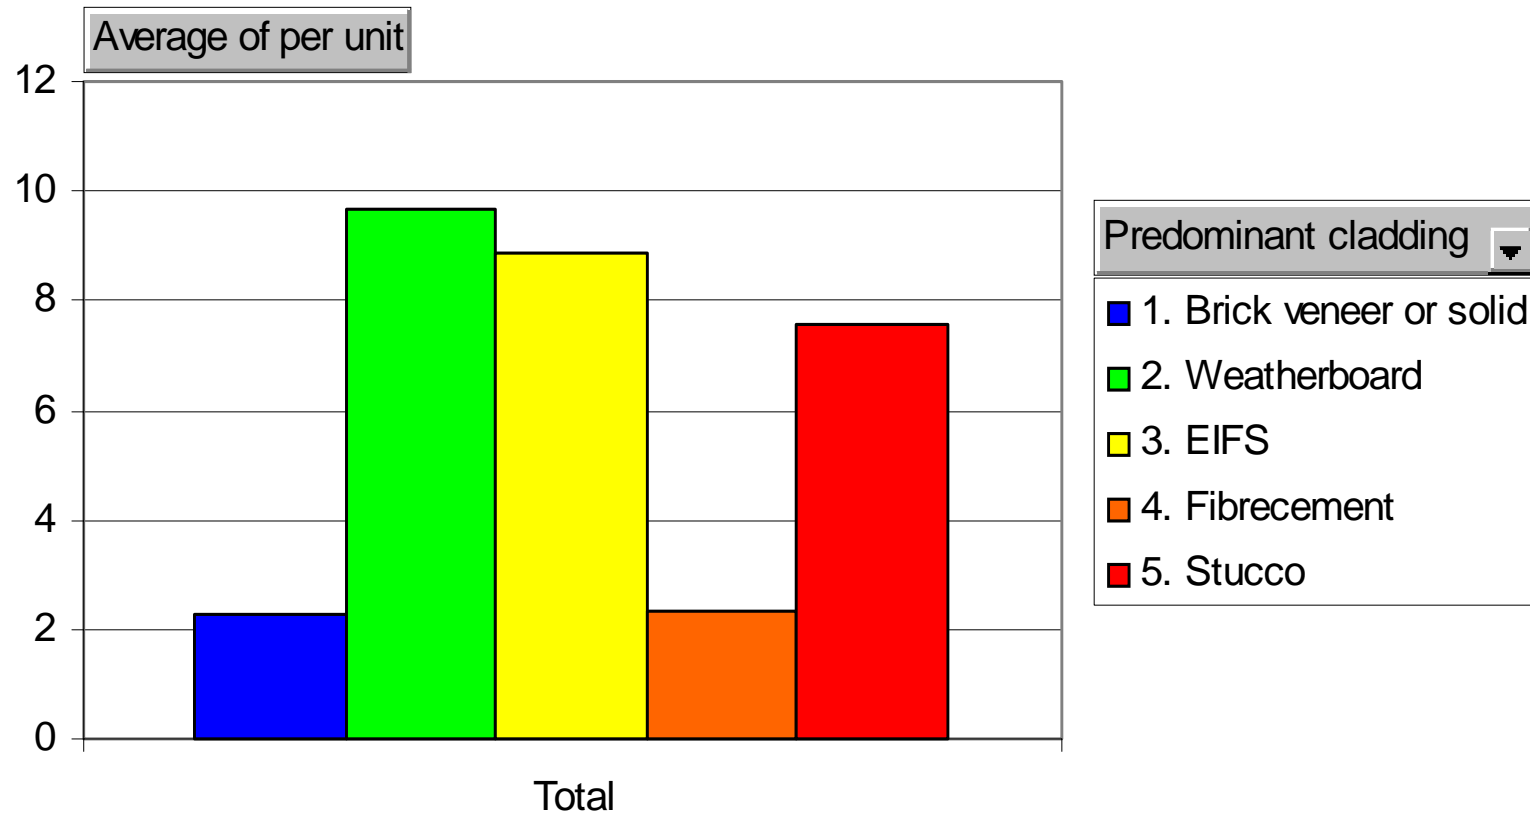
Predominant Cladding vs Wall Leaks Per Unit

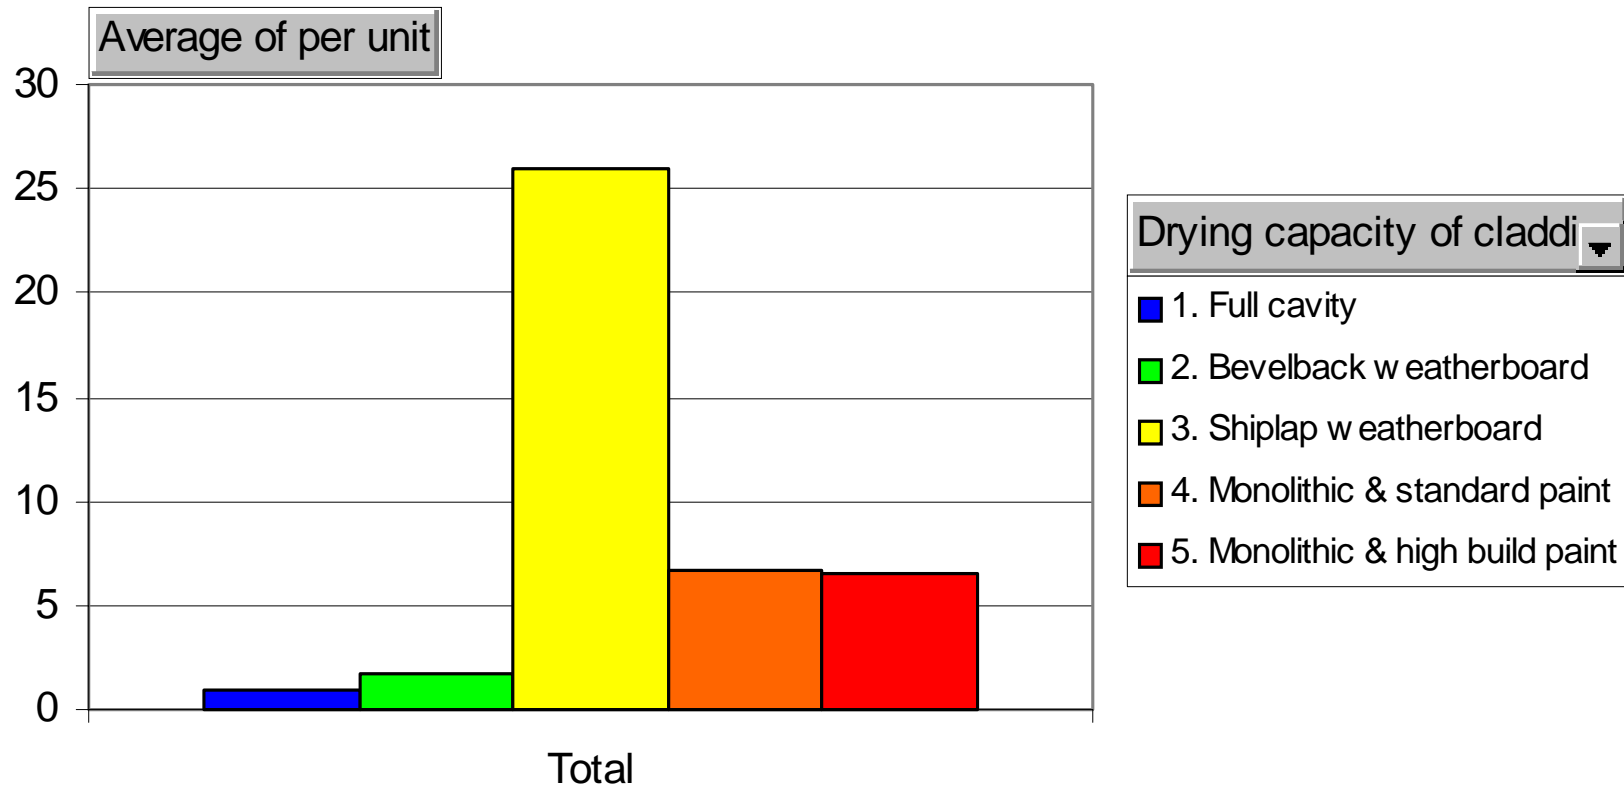
Cladding Drying Capacity vs Wall Leaks Per Unit

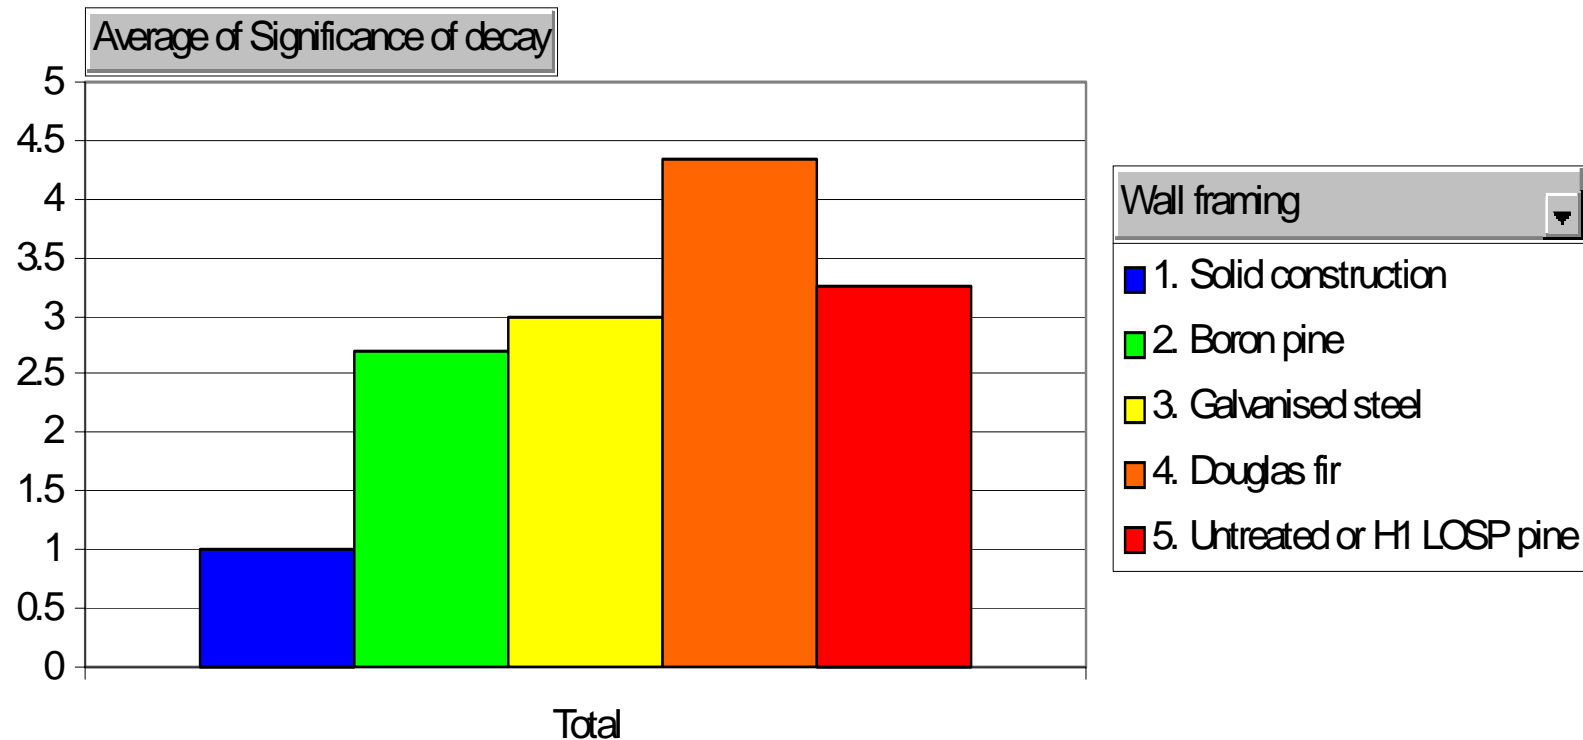
Framing vs Significance of Corrosion Decay (Average)

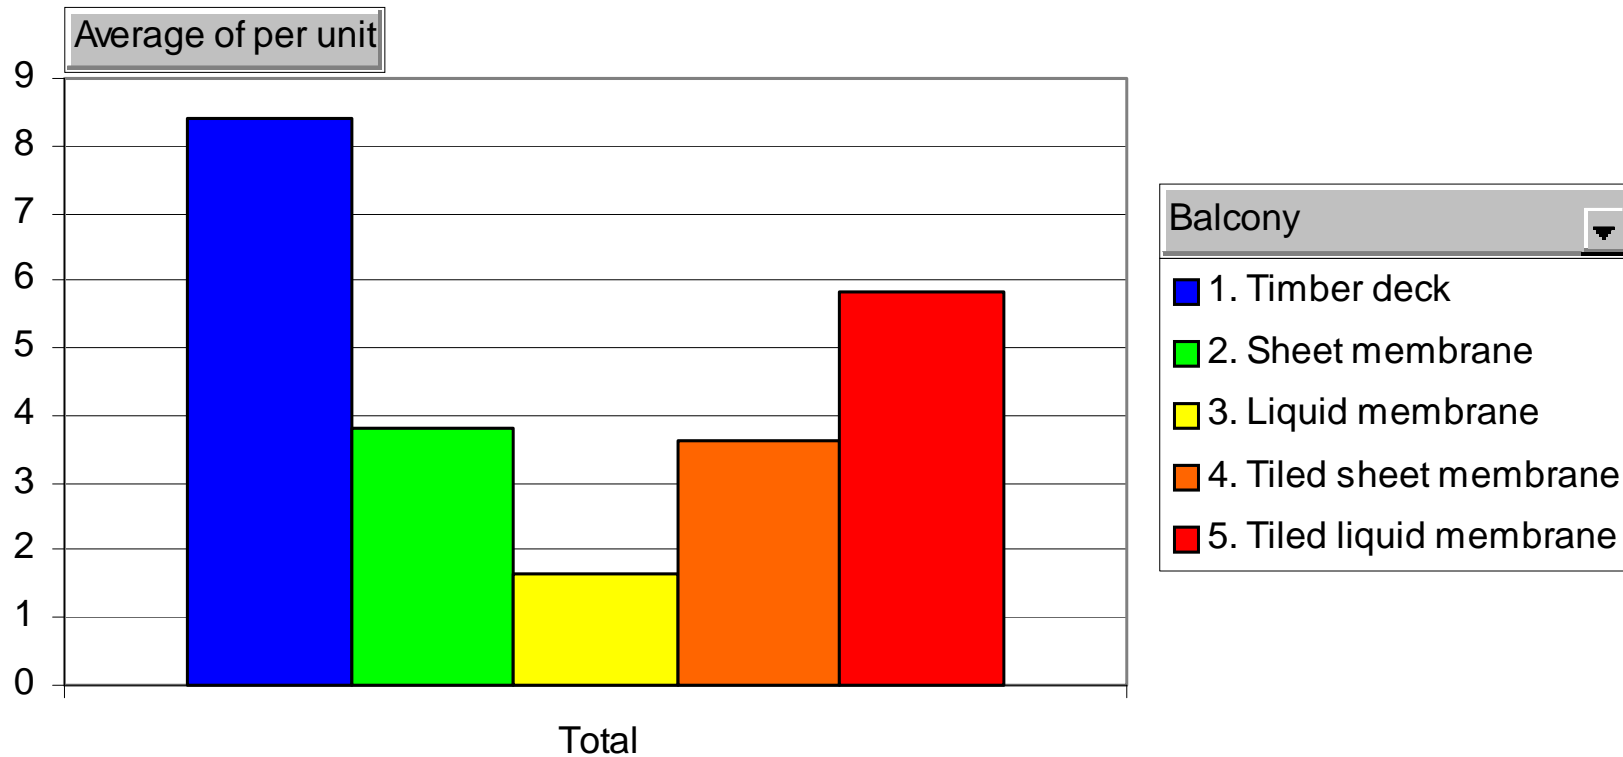
Balcony vs Balcony Leaks Per Unit
